TEST REPORT RAPPORTO DI PROVA

Frontal impact on model TI-VAN Prova di urto frontale su allestimento TI-VAN

Test report n.: MEC15070.00_TR
Revision: 00
Document name: MEC15070.00_TR.doc

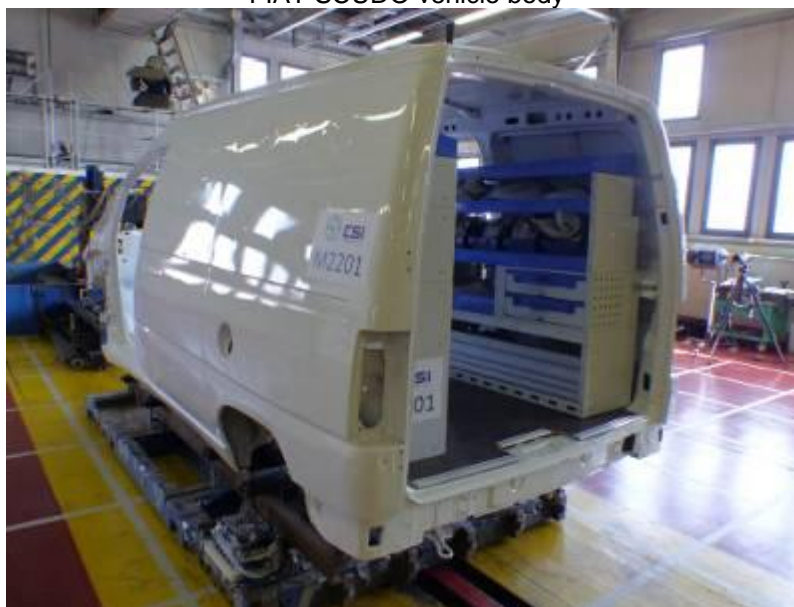
TI-VAN before the test

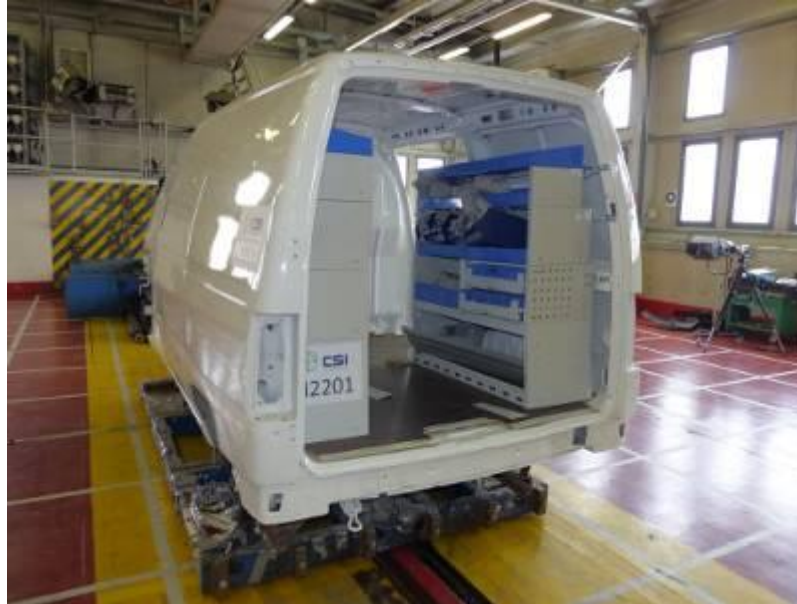
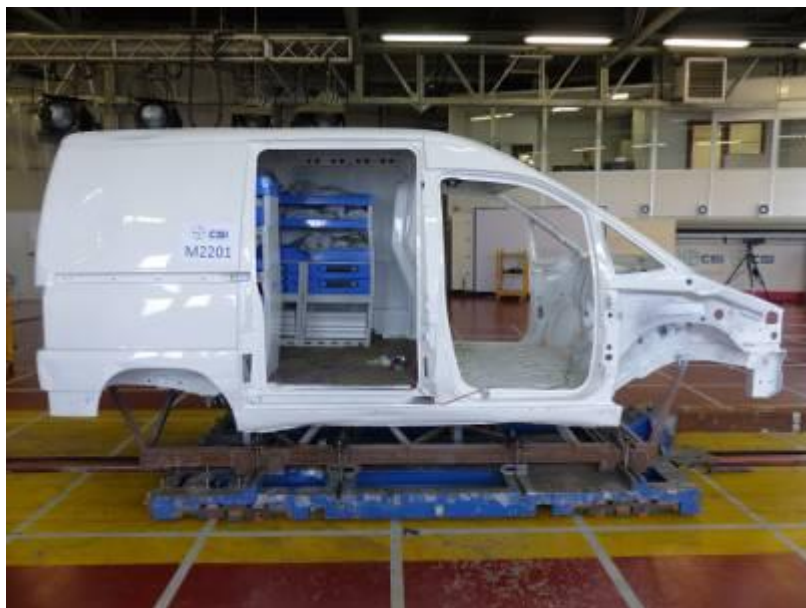
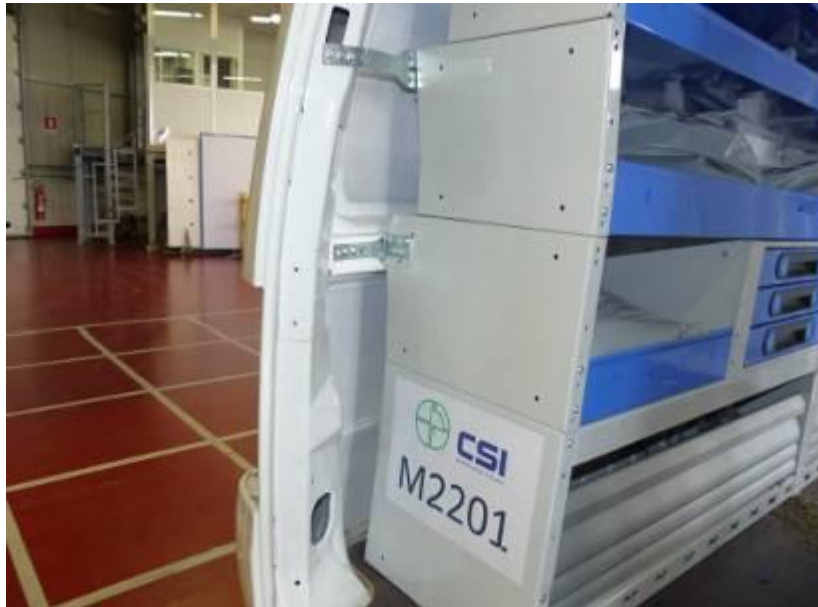
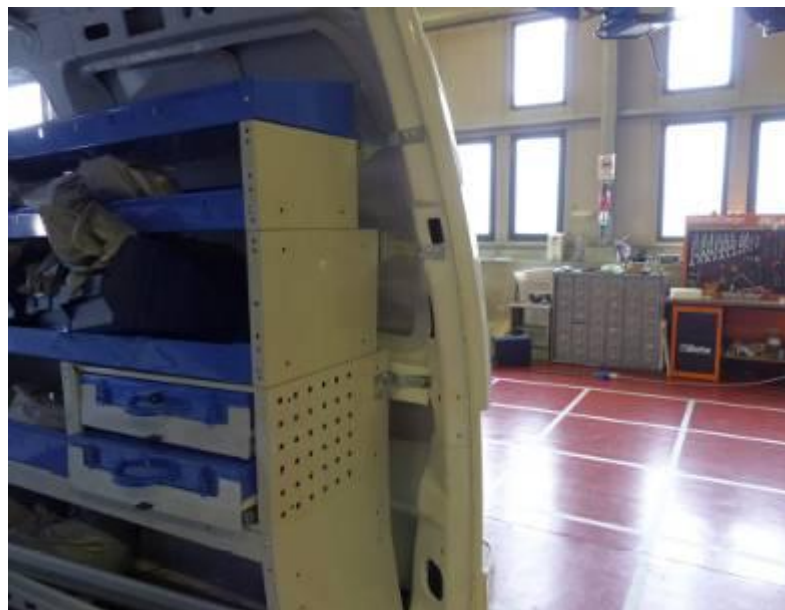
TI-VAN after the test

- no recognizable fractures of any of the safety relevant components
- no losing of attachment parts
